## Project Case Study

**Project:** Cactus Theater built 1938

**Location:** Lubbock, Texas

**Application:** Rainwater Collection

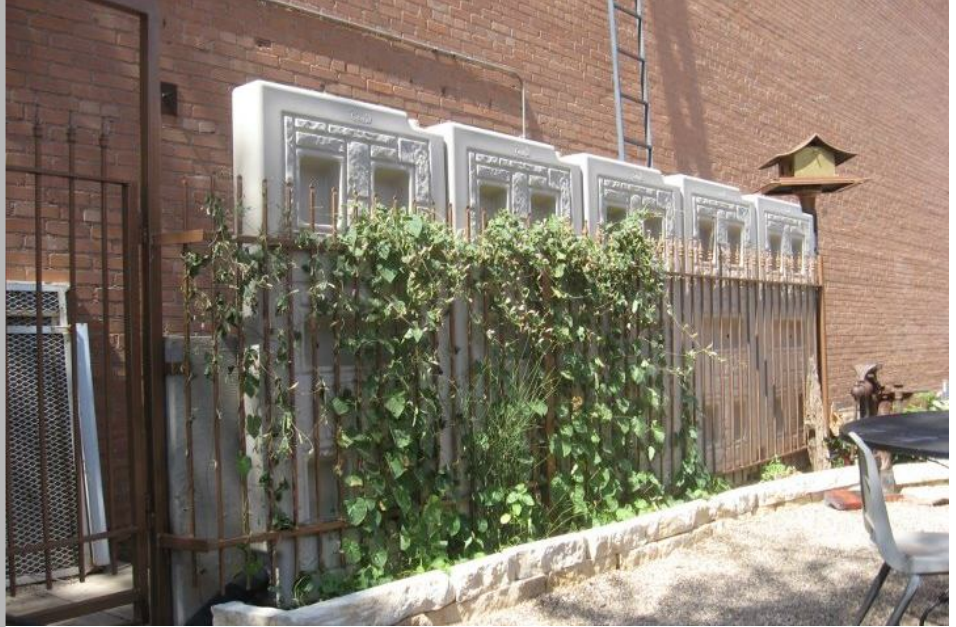
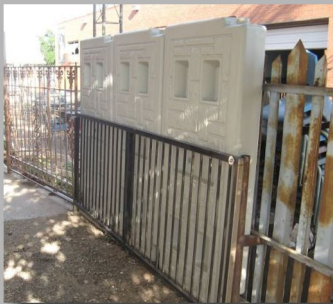
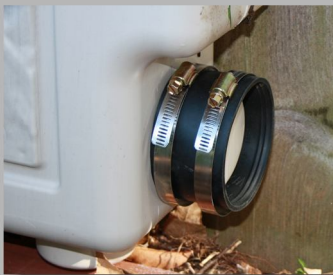
**System:** 15 Contain Rainwater Wall Tanks daisy chained together to create a rainwater collection / harvesting wall in two separate areas of the building.

Seen in this project study is 15 Contain Rainwater Wall Harvesting Tanks setup in two banks and daisy chained together.

Water is collected from the gutters on the roof when it rains and stored in the tanks for irrigation and landscaping purposes.

This setup gives this customer a potential 930 usable gallons of rainwater in each rainfall eliminating cost and irrigation water otherwise used from the city.

- 15 Contain Rainwater Wall Rainwater Harvesting Tanks
- 14 Contain Rainwater Wall Connection Couplers
- 2 Rain Harvest Leaf Catcher Filters supplied by Contain Water Systems
- 1 @ 1.5 inch Built in outlet hooked to pump and hose
- 1 @ 3" Overflow Kit
